TECHNICAL REPORT S-76-15

## PAVEMENT DETERIORATION ANALYSIS FOR DESIGN AND EVALUATION SYSTEMS

Victor C. Barber, Eugene C. Odom, Robert W. Patrick

December 1976

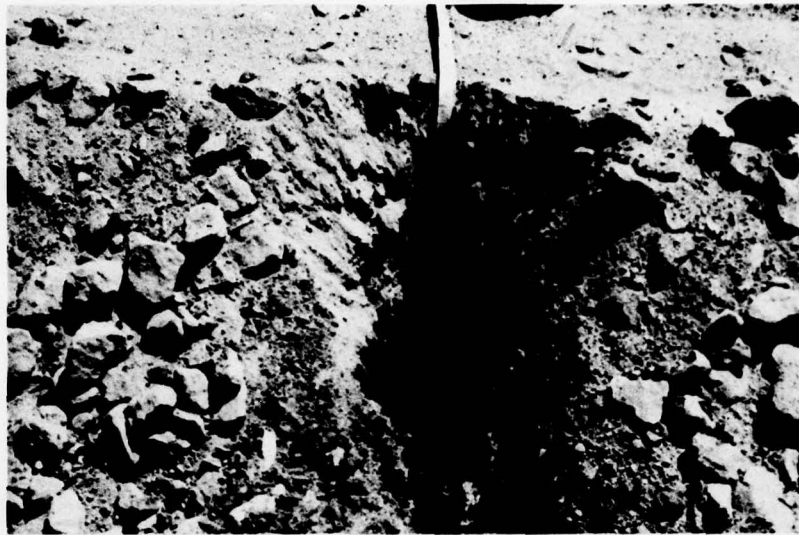
Photo 9. Exposed cross section at site 5 showing depth of aggregate surface course

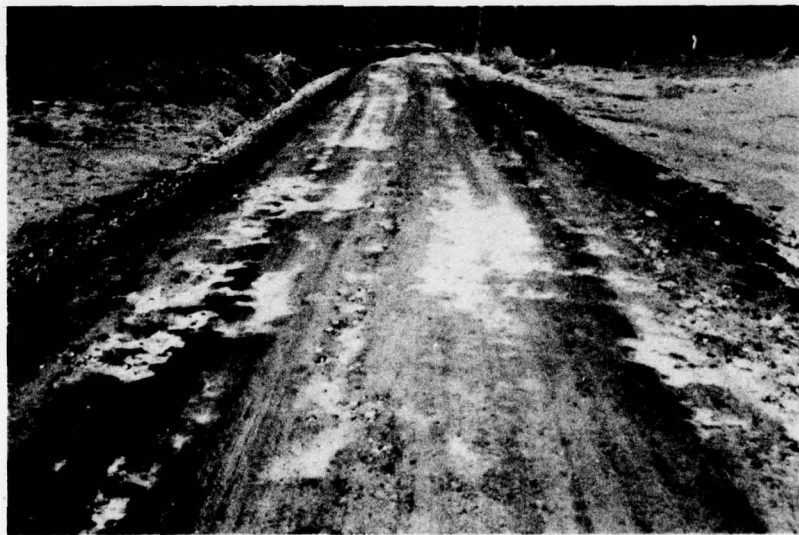
Photo 10. Deterioration of dust-oil layer on site 5

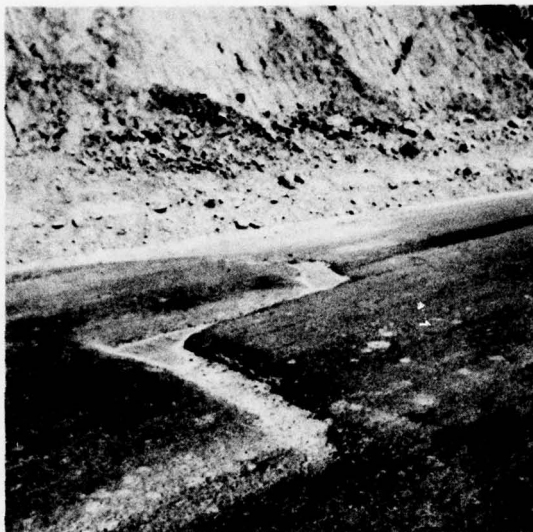
Photo 13. Failure of flexible  
pavement on Cottonwood Road

the asphalt surfaced, aggregate surfaced, and unsurfaced roads. There were several small localized failures requiring extensive patching in the asphalt pavement of Cottonwood Road. These were located mainly in the downhill westbound lane between mile 4 and mile 9. Two of these failures are shown in Photos 13 and 14. Most of these localized failures were slippage failures caused by the loss of bond between the surface layer of asphaltic concrete and the underlying asphalt. The maintenance consisted primarily of excavating and replacing the damaged material in the area surrounding the failure. Site 1 had one failure area in the westbound lane that was repaired on 20 and 21 May. Another slippage failure was observed in the eastbound lane of site 1 on 7 June. The section of Cottonwood Road having the most failures was given a 2-in. asphalt overlay on 28 June. This 1.2-mile section, which included site 1, was located between miles 6.9 and 8.1.

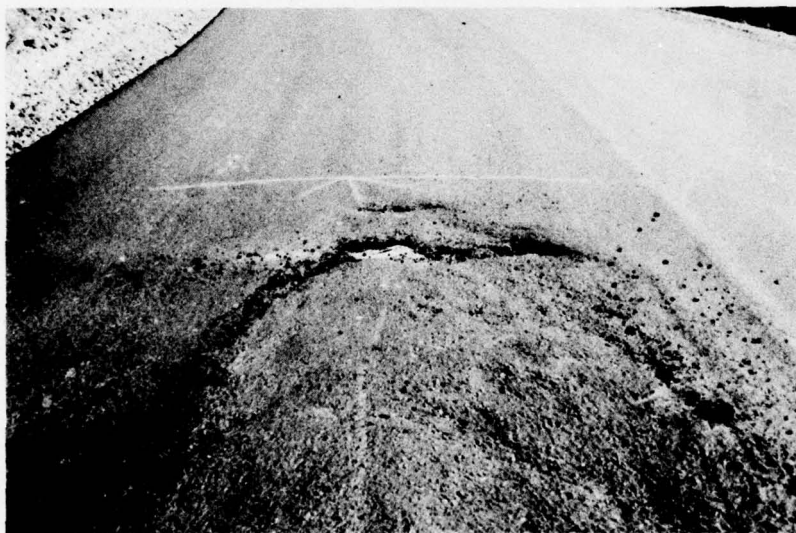
Photo 14. Failure of flexible pavement on  
Cottonwood Road

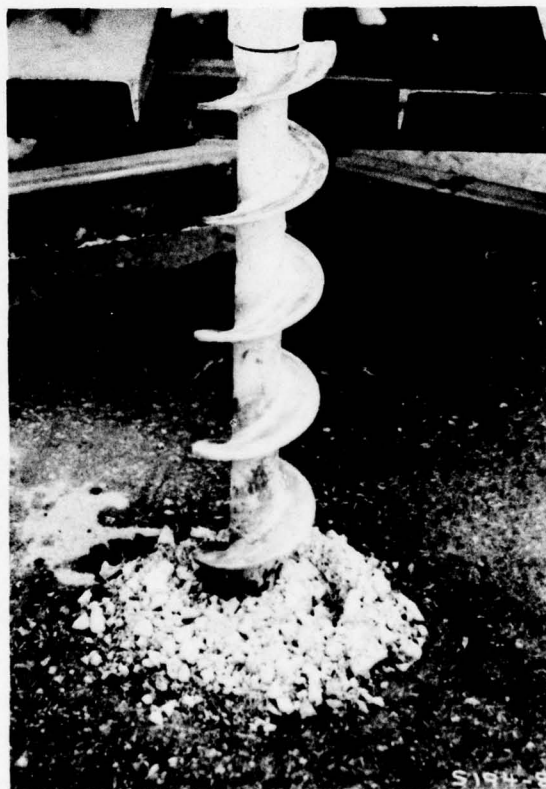
Photo 25. SAT auger for base and subbase

deterioration at all seven sites at various intervals. Most of the testing was accomplished by a SAT procedure that is described in detail by Hall and Elsea.<sup>1</sup> The SAT equipment consists of a small trailer-mounted drill rig (shown in Photo 23) which has a standard 6-in.-diam core drill. Hydraulic lifting jacks were installed in the trailer to provide a stable working platform. An important feature of the drill rig is the sliding-base arrangement which allows the coring of the pavement, the removal of the drill assembly from the hole to perform the desired tests, and the automatic realignment of the drill assembly for further advancement of the hole. A thin-walled diamond-core barrel was used for coring the asphalt pavement as shown in Photo 24. An auger was used for advancing the hole into the base or subgrade as shown in Photo 25.
